# FERMI-I FUEL MELTDOWN INCIDENT

© M. Ragheb  
11/20/2014

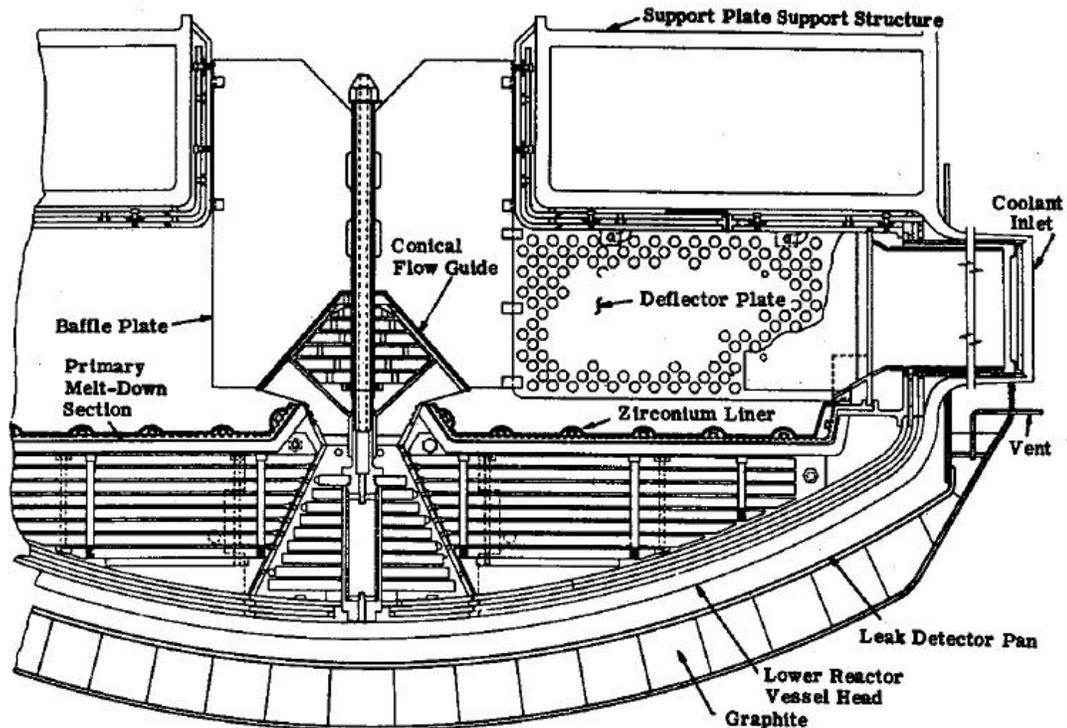
A piece of debris referred to as “foreign object” was found stuck in the inlet plenum. This proved later to be a loose crumpled Zircaloy plate from the melt-down section liner.

At the bottom of the core, 6 small Zircaloy plates had been installed to direct the Na coolant flow to the upward direction. One of these 6 plates broke loose and caused flow starvation at the entrances of the fuel assemblies.

The loose Zircaloy plate had been swept away by the flowing coolant and floated to different locations to partially or completely cover the inlet nozzle of various fuel assemblies during the multiple shutdowns and startups.

Figure 4. Fermi-1 core coolant inlet, dispersion and meltdown section. The loosened plates Zircaloy at the inlet coolant flow were broken loose to partially or totally obstruct one or the other fuel subassemblies inlet plenums during startups and shutdowns.

The Zircaloy plates were found not to be included in the original reactor design and were added at a later stage in the design.

Any late fix-ups should be strictly avoided in the design and construction of reactor systems especially since these late additions would escape the quality control and design scrutiny of the other components.

Since the Fermi-1 incident, the inlet nozzles for the fuel assemblies include multiple coolant inlet passages so that complete external blockages would not be possible.
